All About PB (Polybutylene) Plumbing Pipes

From "Plumbing Express" - see their web site: www.polybutylene.com

Polybutylene Pipes and Insert Fittings

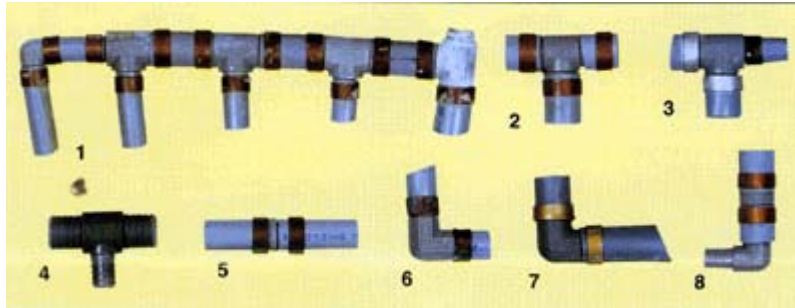
These are typically gray or white in color with a dull finish. Most are shown with pipe attached. Figure (4) is a new fitting. The piping systems were used for underground water mains and as interior water distribution piping. Industry experts believe it was installed in at least 6 million homes, and some experts indicate it may have been used in as many as 10 million homes. Most probably, the piping was installed in about one in every four or five homes built during the years in which the pipe was manufactured.

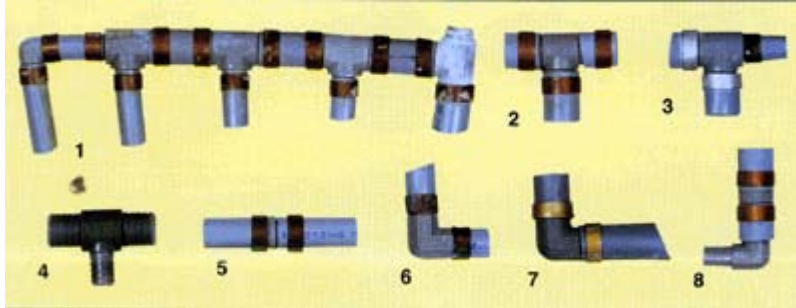
These are typically gray or white in color with a dull finish. Most are shown with pipe attached. Figure (4) is a new fitting.

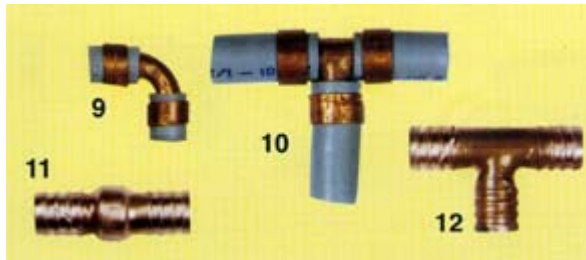
Metal Insert Fittings-

These are typically made of copper or brass. New fittings are shown in (11, 12).

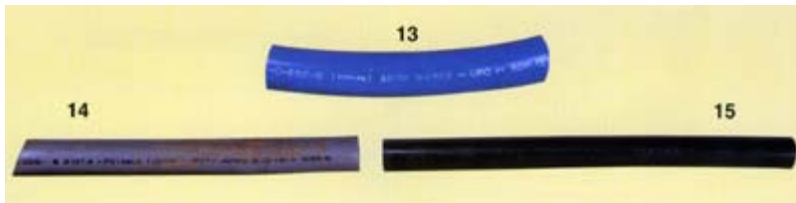
Polybutylene Pipe- Yard Service Line is typically blue (13), gray (14), or black (15). Inside Pipe is typically gray (14) or Black (15).

Exterior - Polybutylene underground water mains are usually blue, but may be gray or black (do not confuse black poly with polyethylene pipe). It is usually 1/2" or 1" in diameter, and it may be found entering your home through the basement wall or floor, concrete slab or coming up through your crawlspace; frequently it enters the home near the water heater. Your main shutoff valve is attached to the end of the water main. Also, you should check at the water meter that is located at the street, near the city water main. It is wise to check at both ends of the pipe because we have found cases where copper pipe enters the home, and poly pipe is at the water meter. Obviously, both pipes were used and connected somewhere underground.
